TECHNICAL REPORT NO. 358

Sutherland 2012 June Installation of Tiger Counters

Steven J. Hale

2012 July 26

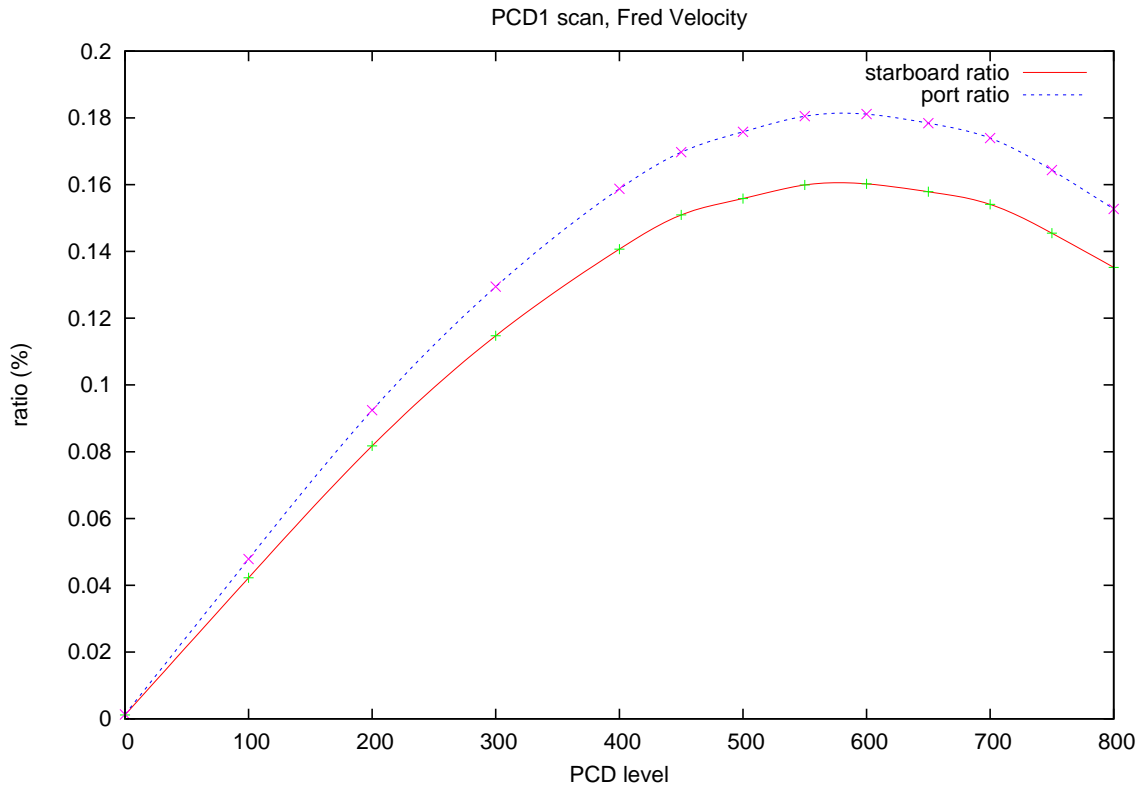
The delta-B was disconnected and the magnetic Pockels cell removed. The driver was scanned over the full range while looking at the velocity ratio output from the detectors. The results are in figure 1. The initial setting was “750”, the new scan suggests the best setting is “575” and so the velocity driver was adjusted to the new optimum.

Figure 1: Velocity PCD scan.

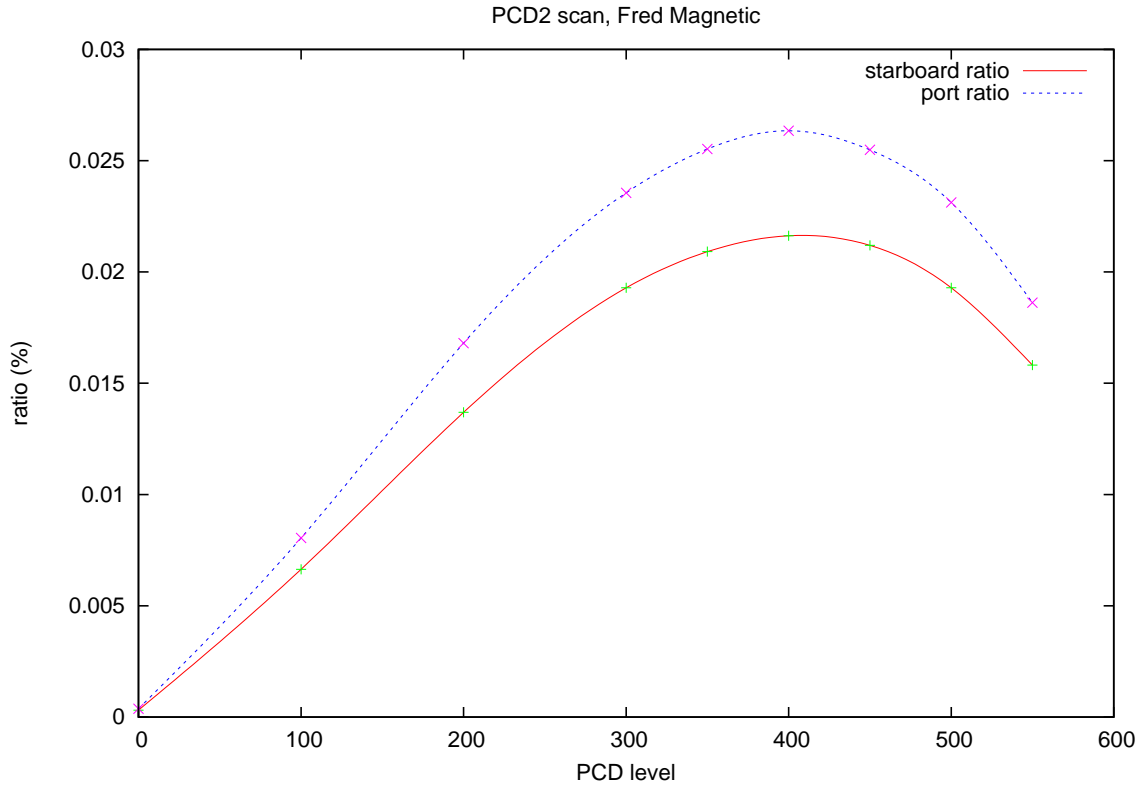
Calibrating the magnetic Pockels cell is slightly more tricky. The magnetic Pockels cell was replaced, and the velocity Pockels cell removed. The magnetic Pockels cell was then moved behind the polariser into the velocity position. The scan was then repeated using the magnetic cell and driver. The results are in figure 2. The initial setting was “375”, the new scan suggests the best setting is “400” and so the magnetic driver was adjusted to the new optimum.

Figure 2: Magnetic PCD scan.
